VOLUNTARY RECALL – 51C013: HYUNDAI Elantra (HD) and i30 (FD) Power Steering

Technical Service Bulletin

Model:	i30 (FD) , Elantra (HD)			Issue Date:	21st August 2015
TSB Type:	Recall	Campaign Number:	51C013	TSB Number:	SE15042
Group:	Steering System	Parts Availability:	Refer Parts Dept.	Supersedes:	-
Subject:	Heavy Steering Wheel Repair

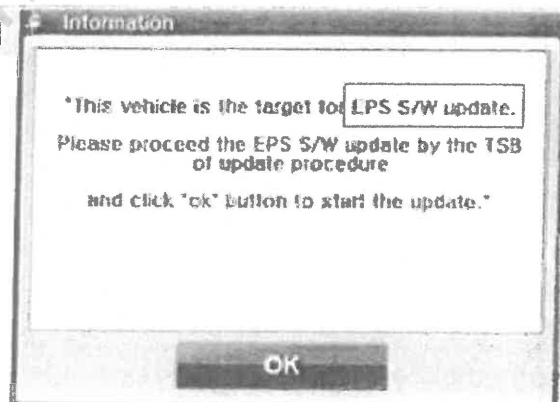
Figure 1 - S/W update -

Proceed with Service Procedure 5.1

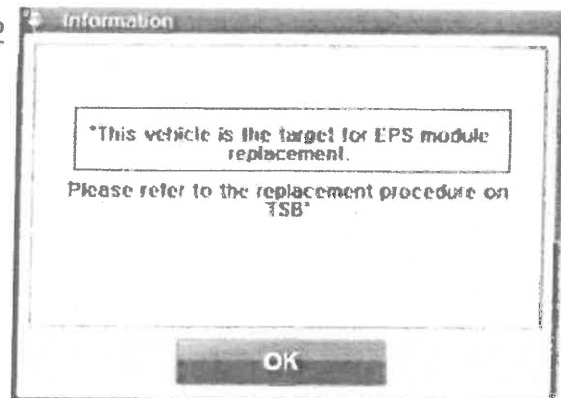
Fig 2

Figure 2 - Module replacement -

Proceed with Service Procedure 5.2

NOTE: If the GDS or GDS-Mobile message is 'EPS Module Replacement' Take a screen capture. This is required for the warranty claim

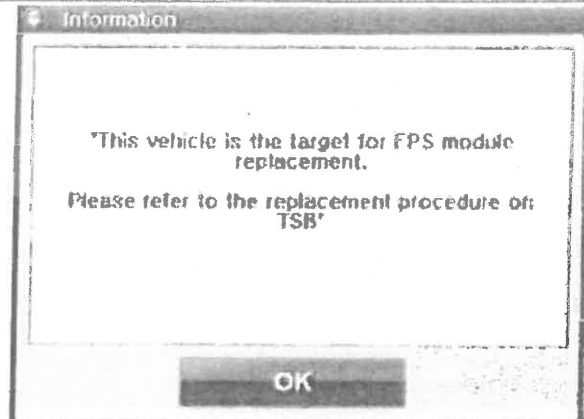
- 1) Ensure to carry out a screen capture of the GDS or GDS- Mobile EPS Module replacement request.

- 2) Replace the MDPS unit referring to the applicable shop manual.

NOTE: After replacement of the MDPS, carry out the following:

- EPS type recognition
- ASP (Absolute Steering Position) Calibration
