Report on the ability of independent repairers to access information and data to repair or service new cars

Rowan Carter – Cartech Pty Ltd

Date: 3 July 2017

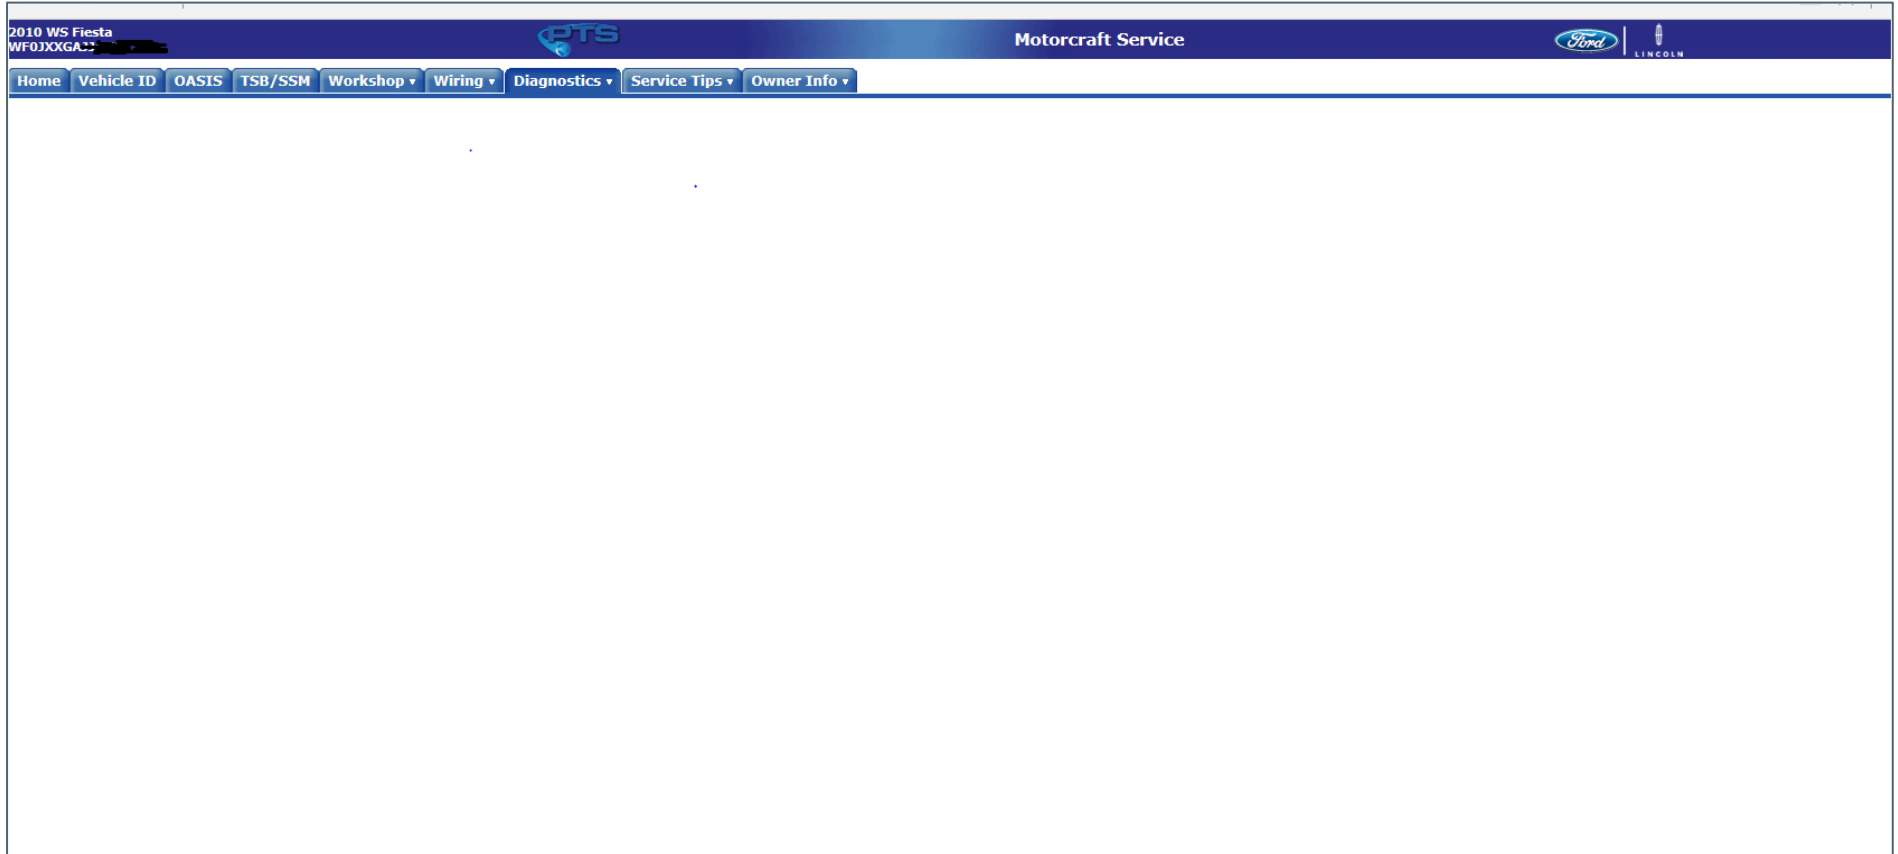
Attachment B7.A – Diagnostic information available for the sample vehicle used (showing no information)

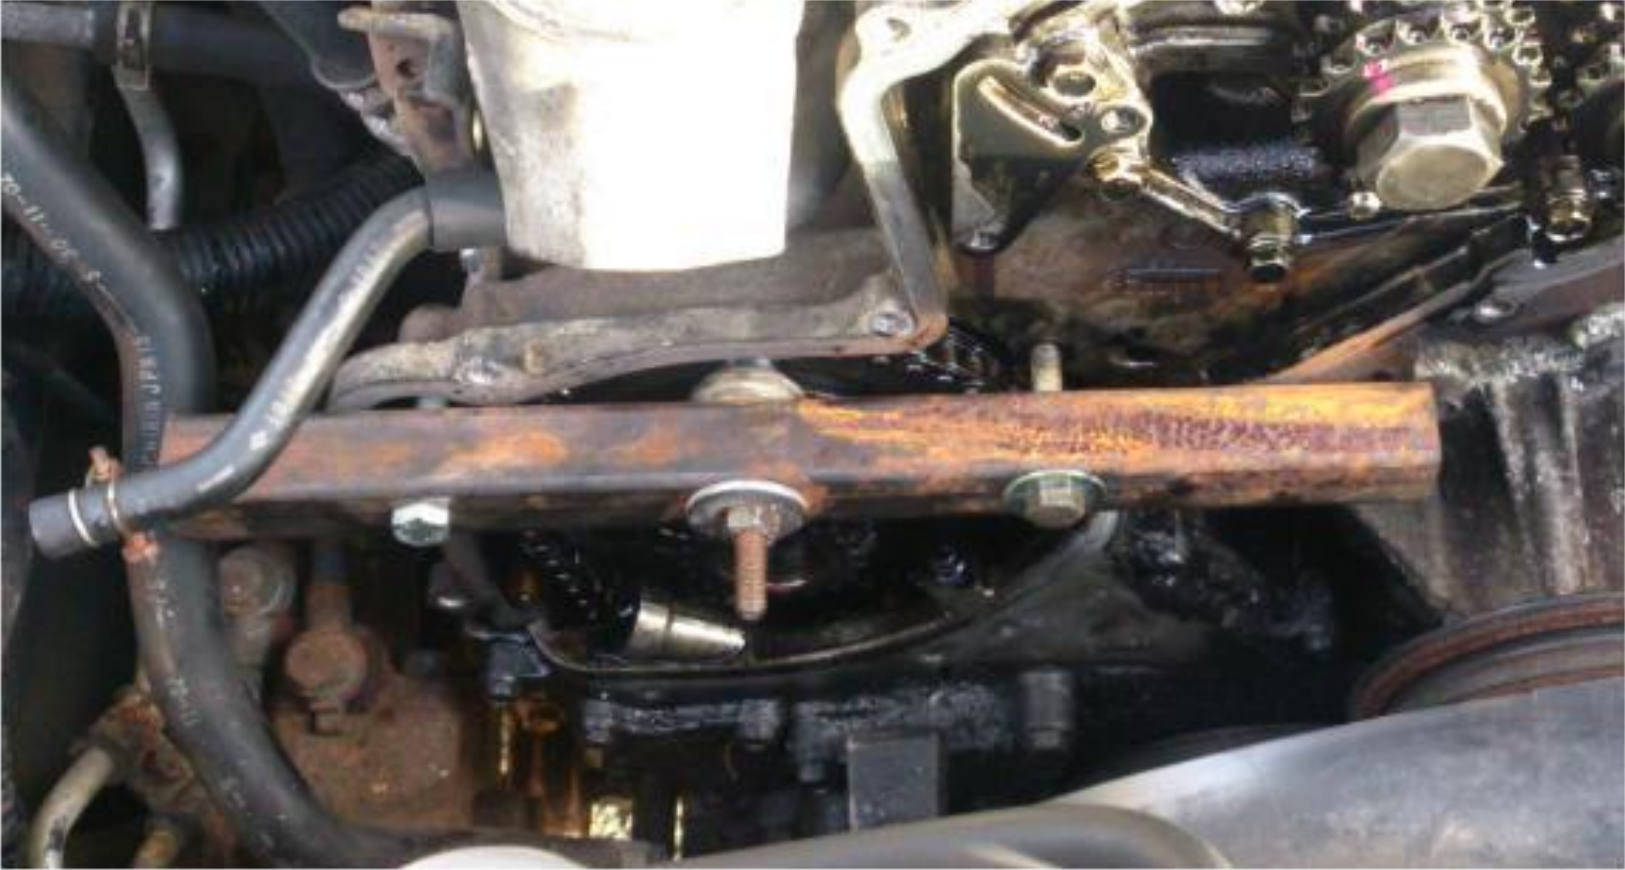
Attachment B10.B – Makeshift tool from online Nissan forum
