Supplementary report
on the ability of
independent repairers
to access information
and data to repair or
service new cars:
Review of May 2017
FCAI submission

Rowan Carter – Cartech Pty Ltd

Date: 12 July 2017

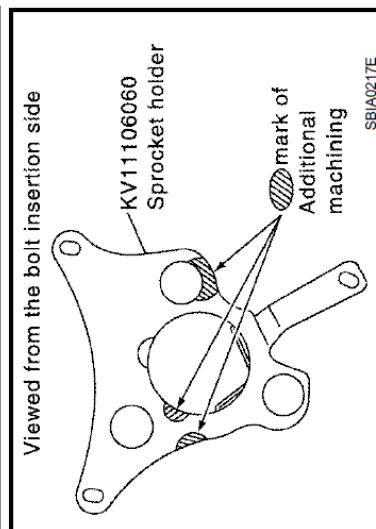
[YD]

- Using the sprocket holder (SST), hold fuel pump sprocket to prevent falling.
 - Rework sprocket holder (SST) to use, as shown in the figure.

<p>complicated procedure for removing the high pressure fuel pump using a special service tool (PN KV11106060 — see Appendix H). It does not appear that the 3.0L diesel model (the V9X engine) encounters the same difficulty.</p> <p>Secondly, as noted in Cartech’s 3 July 2017 report, this tool was unable to be readily sourced from the dealer (the manufacturer’s response indicates that there are no restrictions on an independent repairer purchasing from a dealer).</p> <p>NB Cartech notes that the terms of its initial engagement with the ACCC were in relation to gaining access to information to facilitate repair, which was the focus of its assessment for this reported issue (noting that the reported issue was about gaining information to access and use the tool in addition to sourcing it).</p>	<p>third-party tool supplier - Bosch Australia¹⁹ (noting that the manufacturer’s response suggested that the tool would be available for purchase through a dealer – see Appendix I - email from manufacturer suggesting this tool was no longer available).</p> <p>Cartech notes that a dealer advised that the removal of the high pressure pump on the 2.5 diesel variant could actually be performed without the special service tool referred to in the workshop manual. However, this would involve additional work, such as removal and replacement of the timing chain (see Cartech’s 3 July 2017 report at p. 108).</p>
