FAIR TRADING NSW
NOTIFICATION OF ELECTRICAL ARTICLE RECALL
Issued 13/06/2013.

**RE: PRODUCT SAFETY RECALL
VITALCALL ERICA UNIT – PEARL PENDANTS**

**RE: PRODUCT SAFETY RECALL
VITALCALL MK9 PLUG-IN POWER ADAPTORS MODEL NUMBER A35S0900300**

VITALCALL MK9 PLUG-IN POWER ADAPTORS MODEL NUMBER A35S0900300

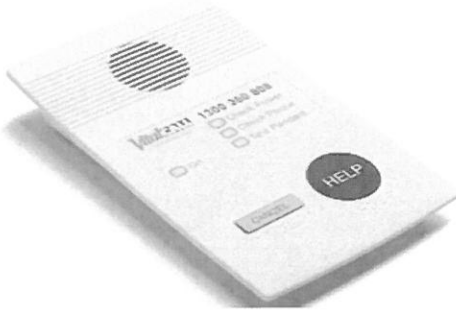
VitalCall model ERICA Unit

Pearl Pendant

PEARL PENDANT USED WITH VITALCALL ERICA UNIT PROVIDED TO CUSTOMERS BETWEEN 1ST JAN 2012 – 15TH MAY 2013

In some circumstances, when certain types of chemicals come into contact with the ERICA unit pearl pendant it may result in cracks appearing on the pendant, which has the potential to compromise its functionality, including waterproofing. The chemicals include but are not limited to:

If the pendant develops cracks, it may compromise the waterproofing and not function in an emergency.

1. **Check your pendant for cracks.** If you see a crack, contact VitalCall immediately, as set out below. Do not use your pendant in the shower or allow it to get wet.
2. Even if your pendant is not cracked, VitalCall will send you a replacement pendant and easy to follow instructions on how to set up your new pendant and return your old pendant.
3. If you have not received your new pendant within six weeks of receiving this notice, please press your pendant and advise the response operator.
4. **DO NOT** let the pendant come in contact with any chemicals, particularly those listed above.
5. Test your pendant every day (if there are cracks) or every week (if there are no cracks) by pressing it and letting the response operator know that you are only testing.

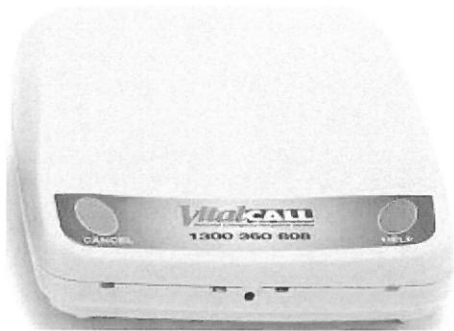
VitalCall model MK9 Unit

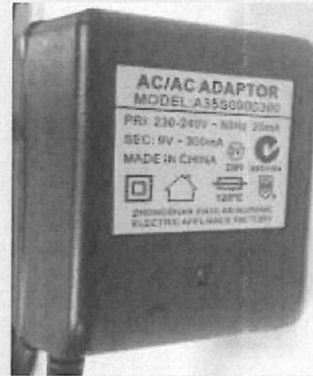
Plug-in power adaptor

PLUG-IN POWER ADAPTORS MODEL NUMBER A35S0900300 SUPPLIED WITH VITALCALL MK9 UNITS PROVIDED TO CUSTOMERS BETWEEN 1st JANUARY 2011 AND 17th MAY 2013

When force is applied to the plug-in power adaptor, or when the adaptor is removed/attempted to be removed from the power socket, surface cracks or breaks may appear on the base of the plug-in power adaptor, or the plug face plate may separate from the adaptor. This has the potential to expose live electrical wires.

If the plug-in power adaptor cracks or breaks, or the plate separates from the adaptor, live electrical wires may be exposed, which could result in injury and/or fire.

1. Check visually (DO NOT TOUCH) your plug-in power adaptor to see if you have model number A35S0900300 that matches the one in the photo above (with a white plate sticker).
2. If you have the plug-in power adaptor with model number A35S0900300, you should contact VitalCall immediately, as set out below.
3. VitalCall will arrange for a qualified professional to contact you to make a time to swap the VitalCall unit and plug-in power adaptor. If you have not been contacted regarding this within 10 days of receiving this notice, please press your pendant and advise the Response operator.
4. **Do not try to remove the plug-in power adaptor, or touch it.**

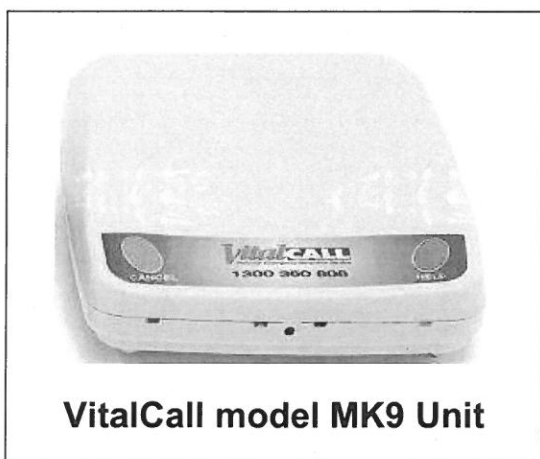
1. Please read carefully the Product Safety Recall Notice enclosed.
2. Check to see if you have a MK9 unit as per the picture, below:

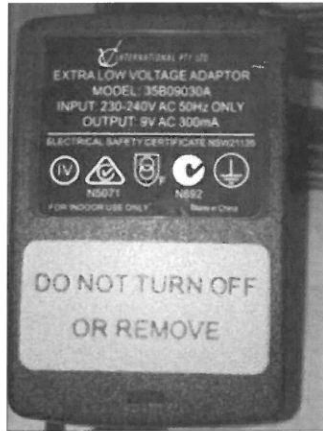
Unaffected plug-in power adaptor.

No further action required

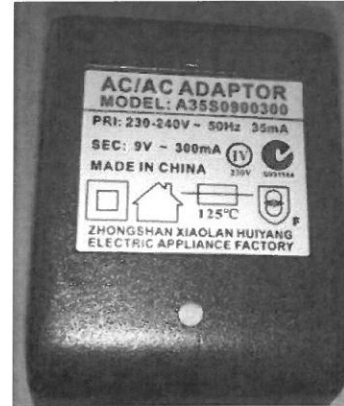
Affected PLUG-IN POWER ADAPTOR

Please contact VitalCall immediately to arrange replacement

4. If you have the plug-in power adaptor with model number A35S0900300, you should contact VitalCall immediately, as set out below. VitalCall will arrange for a qualified professional to contact you to make a time to swap the VitalCall unit and plug-in power adaptor. If you have not been contacted regarding this within 10 days, please press your pendant and advise the Response operator.
5. **Do not try to remove the plug-in power adaptor, or touch it.** VitalCall urges customers who have the affected plug-in power adaptor to be careful and not touch it, especially when vacuuming around it.
